SCANSHIELD AI

# Sample Roof Inspection Report

AI-assisted findings prepared for professional review

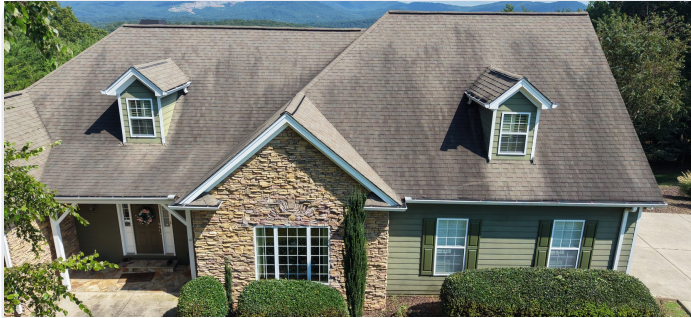
### Algae / Moss

Widespread dark streaking and blotchy discoloration across visible slopes.

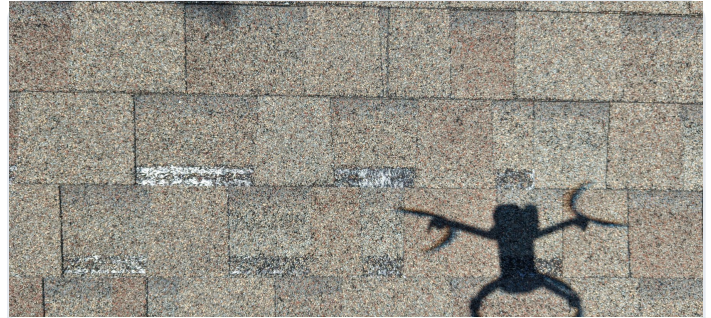
### Shingle Damage

Light-colored sealant or mastic appears applied across multiple shingle courses.

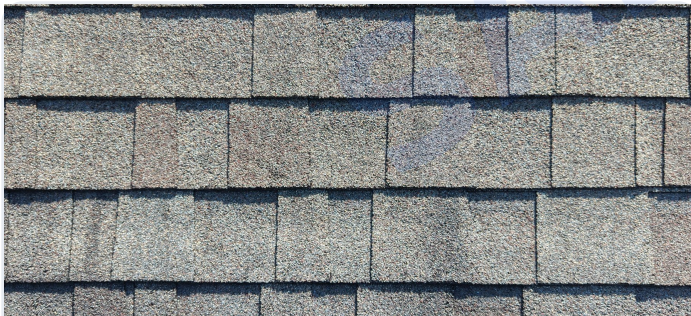
### Granule Loss

Diffuse granule loss consistent with age and weathering.

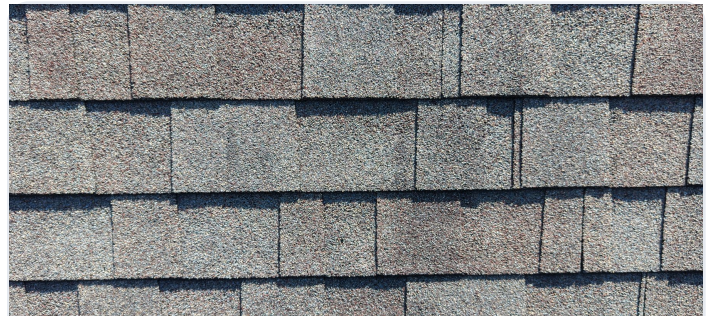
### Hail Damage

Sporadic circular impact marks with localized granule displacement.

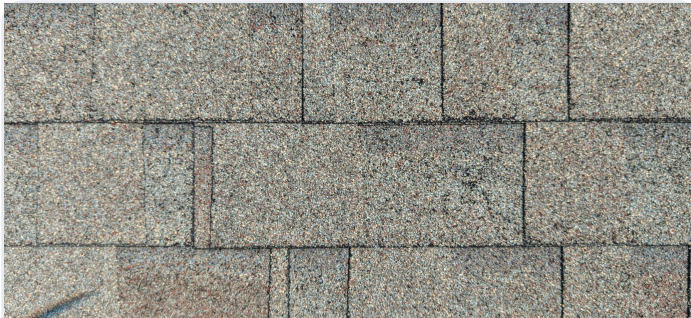
### Hail Damage

Distinct circular impact with granule loss and exposed asphalt mat.

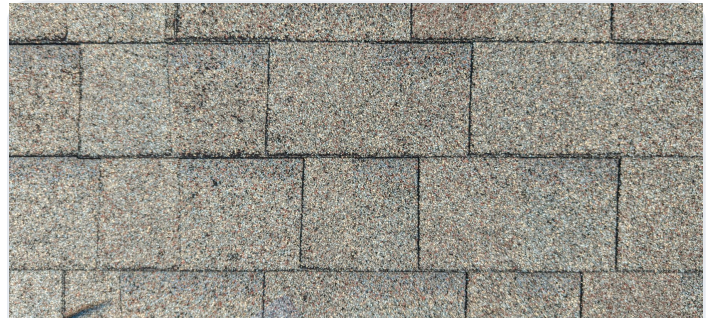
### Hail Damage

Multiple scattered impact marks across visible shingle courses.

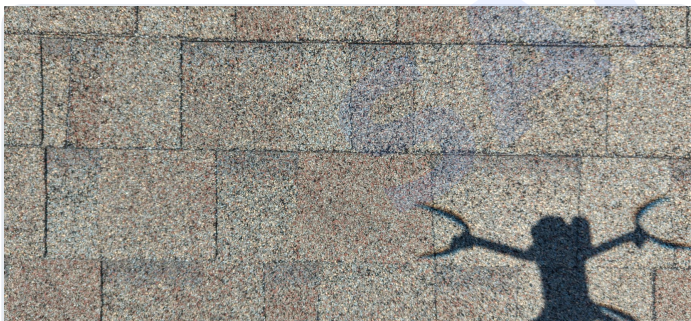
### Hail Damage

Sporadic bruised spots approximately 0.5 to 1 inch in diameter.

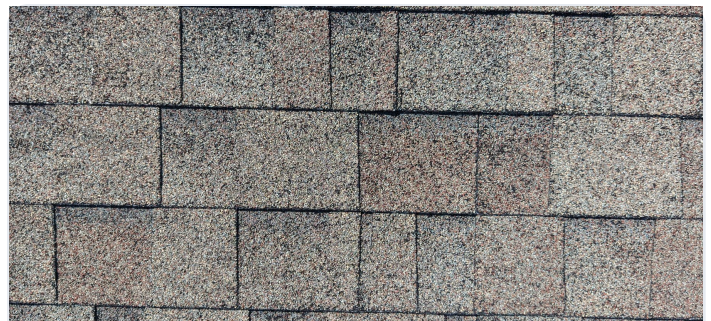
### Hail + Algae

Clearly defined impacts with minor dark discoloration in keyways.
